HILLS CREEK DAM

NDS ID NO. PA-34 **DER ID NO. 59-58**

> PHASE I INSPECTION REPORT NATIONAL DAM INSPECTION PROGRAM

JUNE, 1979

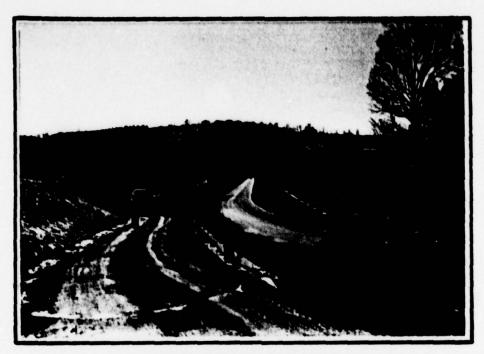
Overview of dam from left abutment.

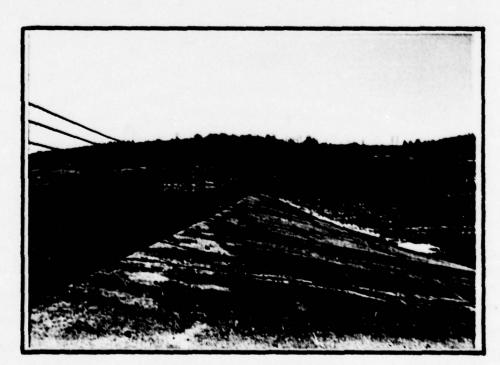
Upstream view of paved slope.

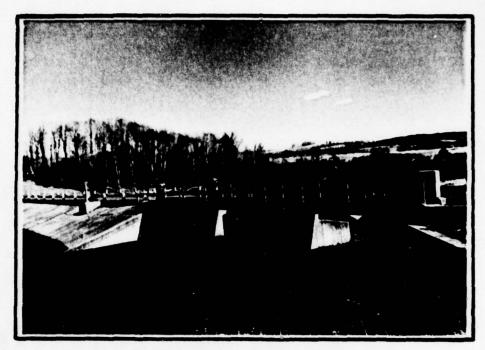
VISUAL EXAMINATION OF CONCRETE WEIR APPROACH CHANNEL. DISCHARGE CHANNEL. C	Concrete ogee in good condition. Lake. Concrete-lined chute in good condition.	REMARKS OR RECOMMENDATIONS
BRIDGE AND PIERS	Bridge crosses the emergency spillway near the weir. Bottom of beam on bridge is at elevation 1494.9 which corresponds to the low point on the top of dam.

Roadway bridge over spillway.

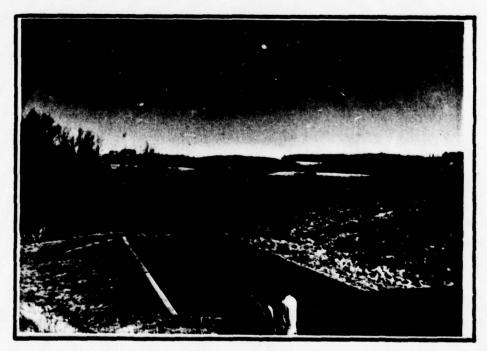
c. Appurtenant Structures. The reservoir level at the time of inspection was 1486.1. About one tenth of a foot of water was discharging over the spillway. The spillway weir consists of a concrete ogee 69 feet long. The ogee weir was in good condition. Above the concrete ogee is the roadway bridge. The bottom beam of this access road bridge was measured to be 1494.9 which corresponds to the low point on the dam. The spillway exit channel consists of a concrete lined chute. All concrete in the spillway facilities appeared to be in good condition.

Spillway exit channel.

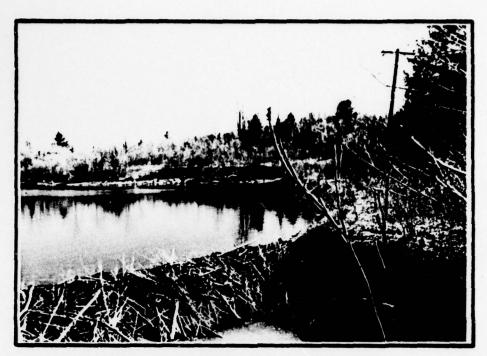
Note: Several small dams located upstream of Hills Creek Dam were constructed by beavers. These dams have failed in the past during heavy storms. These ponds are shallow and in the event of failure, the additional inflow should be insignificant.

Beaver dam upstream of Hills Creek Dam.
